**CALIFORNIA REGIONAL WATER QUALITY CONTROL BOARD  
SAN DIEGO REGION**

**TECHNICAL ANALYSIS**

**Proposed Administrative Civil Liability  
Contained in Complaint No. R9-2005-0264  
City of Carlsbad  
Municipal Golf Course  
San Diego County  
WDID No. 9 37C337203**

**February 10, 2006**

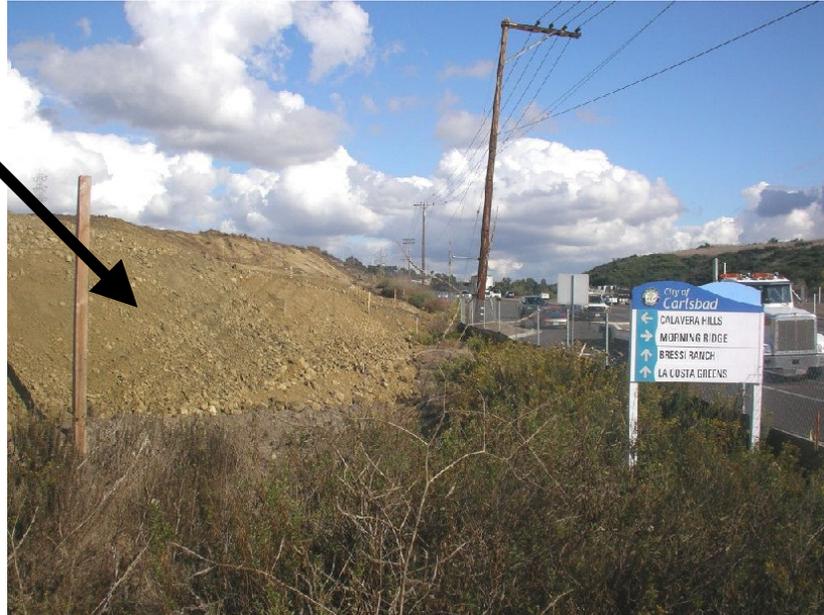
Four days later on October 18, 2005, Regional Board Inspector Eric Becker returned to document any progress that was made. Mr. Becker toured the Site with Skip Hammann, Deputy City Engineer and Mr. Przybyszewski, and completed an inspection report identifying violations. See Exhibit 6, *Inspection Report October 18, 2005*. Mr. Becker noted the complete lack of erosion control BMPs at the Site, specifically that there were "uncovered, exterior slopes throughout the project." As an example, Mr. Becker took the photograph in figure 2 that depicts the exterior slope while standing on Palomar Airport Road looking east toward College Boulevard.

Absence of erosion control BMPs (i.e., mats, soil binders, or hydroseeding) on exterior slopes.

**Figure 2. Looking east along Palomar Airport Road from College Boulevard. Note the absence of erosion control BMPs on the exterior slope. *IMG0933.JPG***

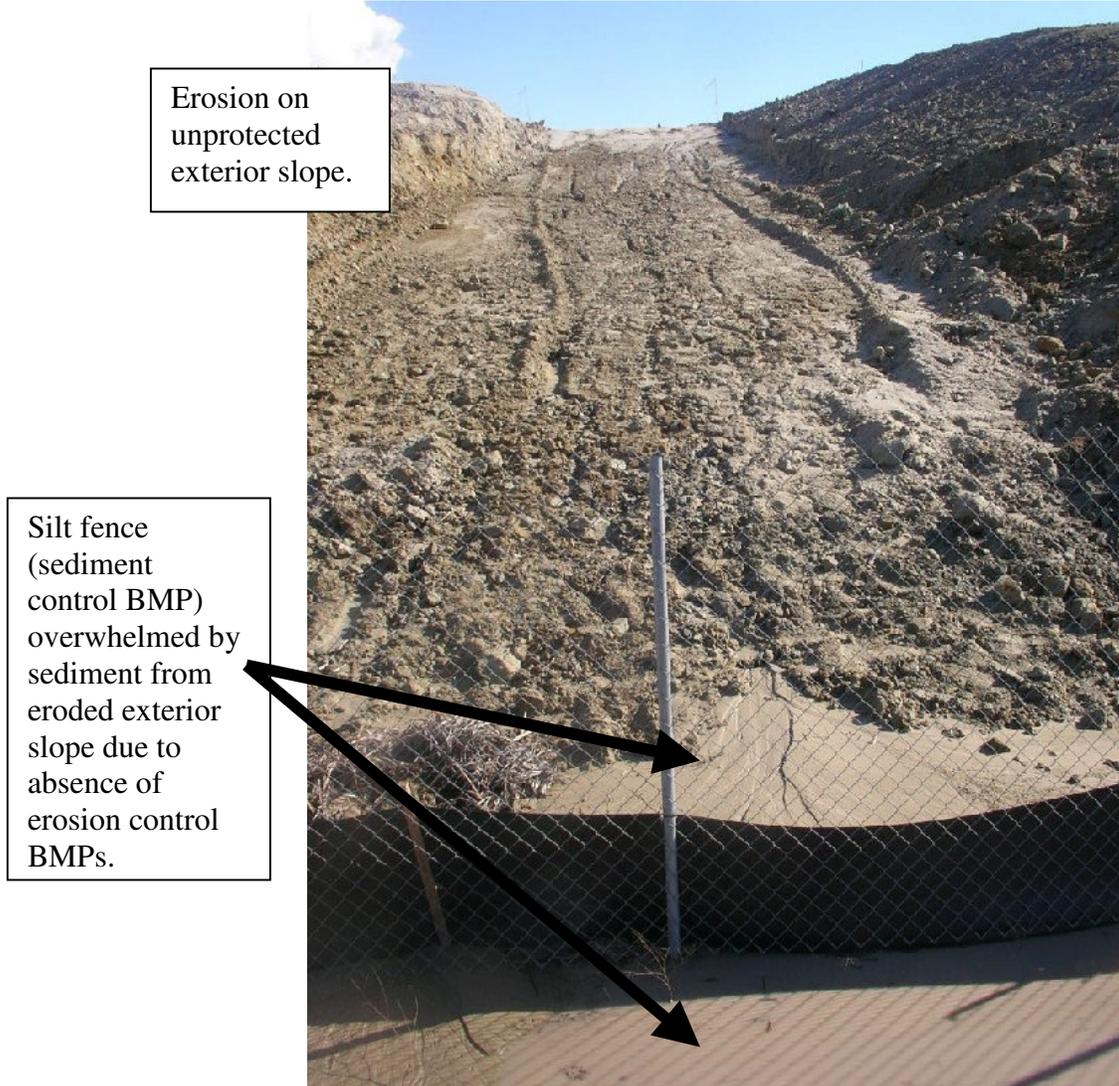
Another example of an exposed exterior slope was observed along the south side of College Avenue. As seen in figure 3, Mr. Becker noted that there was evidence that sediment was discharged off the Site and into the City's storm water conveyance system, however he was unable to quantify how much sediment was discharged.

**Figure 3. Looking south from College Boulevard at erosion on exterior slope that was deposited on the sidewalk. IMG0937.JPG**
